4. TITLE AND SUBTITLE An Overview of Microbiologically Influenced Corrosion in Aircraft				5a. CONTRACT NUMBER	
				5b. GRANT NUMBER	
				5c. PROGRAM ELEMENT NUMBER 601153N

# An Overview of Microbiologically Influenced Corrosion in Aircraft

By B.J. Little and R.I. Ray

Naval Research Laboratory  
Stennis Space Center, MS 39529

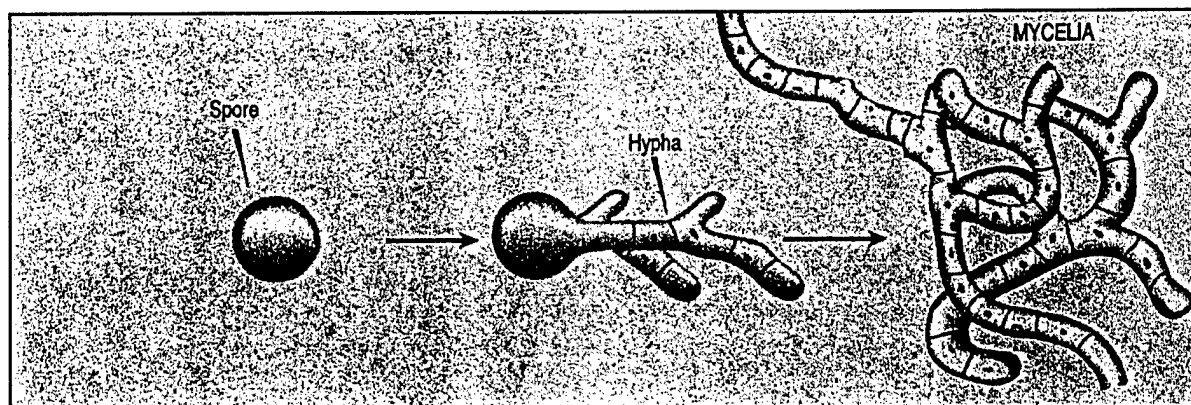
Figure 1. Growth stages of filamentous fungi.

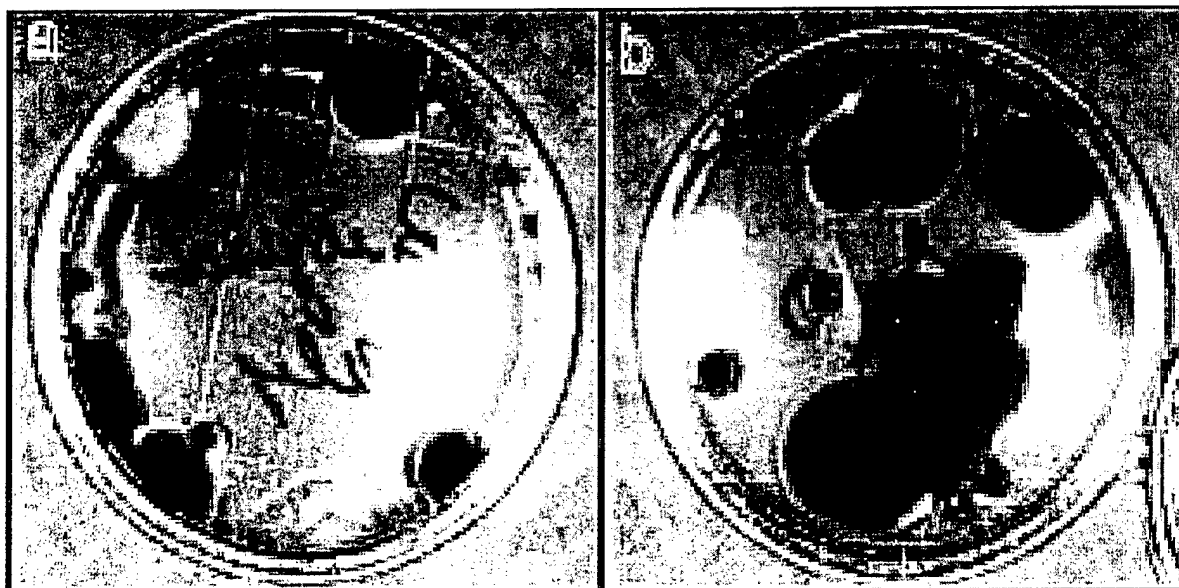
**Figure 5.** Contact plates made from surfaces of a freshly cleaned MH-53J aircraft in the field. (a) contact plate from Figure 4, b3. (b) contact plate from Figure 4, b2. Plates show growth from spores or hyphae left on the surfaces after cleaning.

In situ cleaning of a contaminated bulkhead (Figure 4) was ineffective, as demonstrated by contact PDA plates made after cleaning (Figure 5). The numbers and types of fungi cultured from the surfaces were altered by the cleaning techniques.

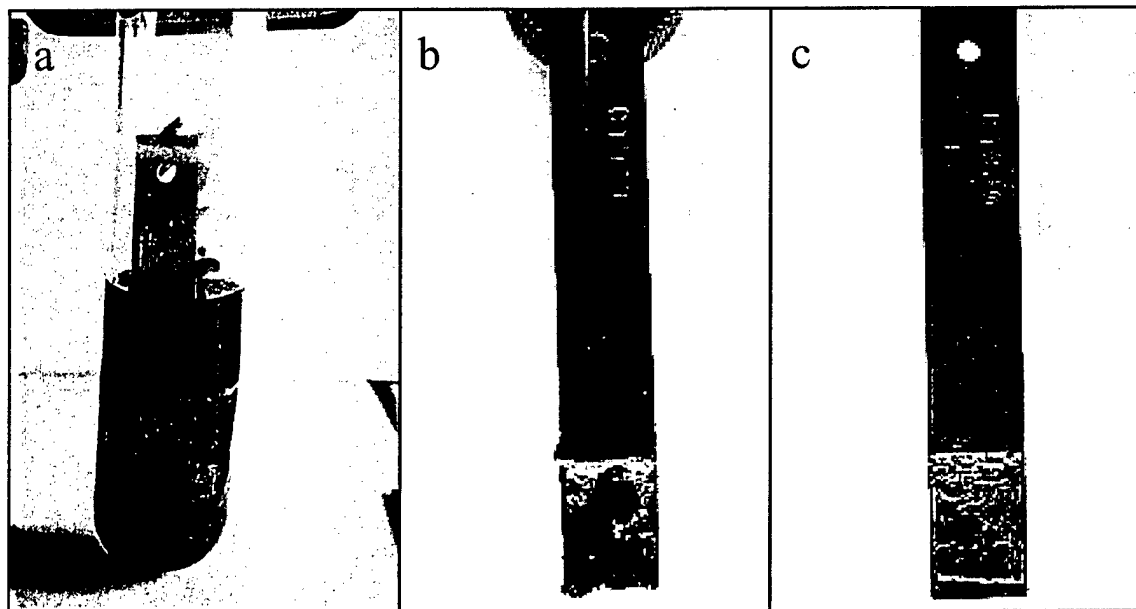
**Figure 7.** a. Carbon steel coupon in jet fuel 5/water combination. Microorganisms growing at fuel/water interface. b. Coupon after removal for fuel/water combination. Microorganisms accumulated on the surface of the coupon at the fuel/water interface. c. Coupon after removal of the biofilm. Corrosion localized at the fuel/water interface and at the bottom of the coupon.

*Aspergillus*, *Penicillium* and *Fusarium* were identified in the fuel/water mixtures. Corrosion attack was located near the tank bottom at the fuel/water interface where an active microbiological population was associated with free water (Fig. 7 a, b, c). Fungi were observed growing over the entire surface of oil droplets and within suspended water droplets (Fig. 8 a, b). In the absence of water, no fungi were detected. Water-soluble biocides are routinely added to fuel to prevent microbial growth. Problems occur when the biocides are exhausted or the amount of water has been underestimated. Attempts to form emulsions of fuel/water combinations accelerate fungal growth by increasing the surface fuel/water interfacial area and, therefore, the availability of oil, oxygen, and nutrients.

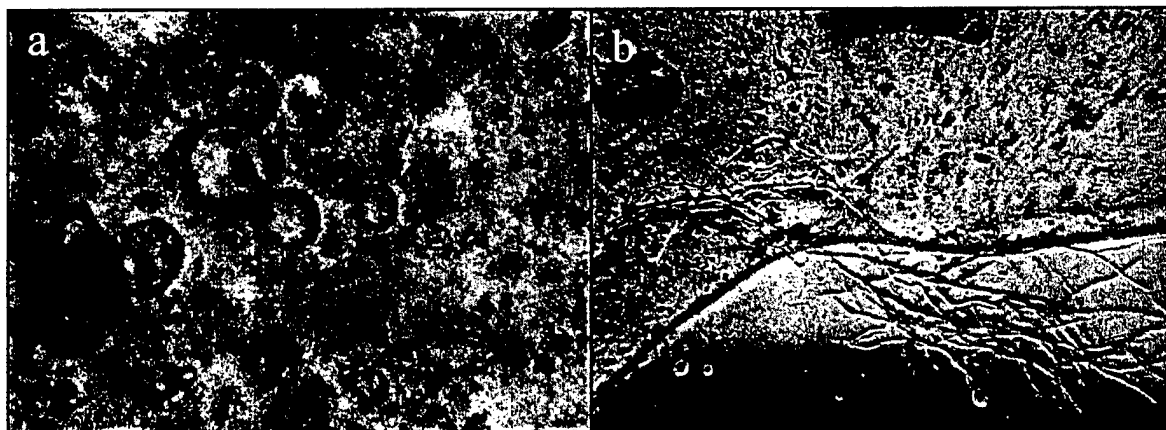
**Figure 8.** a. Water droplets distributed throughout jet fuel 5. b. Fungi growing within a water droplet through the fuel/water interface into the fuel.
